# Fremont Focus Newsletter

### TECHNICAL SERVICE LABORATORY REPORT

**SUBJECT:** Steam Line Deposit Analysis

### Steam Strainer/Trap Corrosion Analysis Results

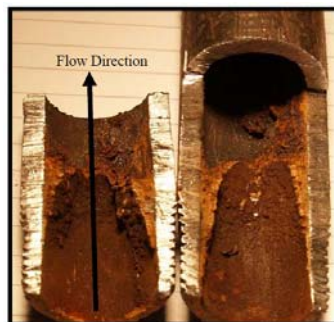
The submitted pipe nipple has been sectioned and internal deposit analyzed as requested. The deposit was found to contain predominately Magnetite which was “cemented” in place by Amine-Carbonates. Trace amounts of Copper and Zinc were also detected, perhaps representative of abraded particulate from a nearby brass valve.

**Photo 1.** Once the pipe was sectioned, it became apparent that the deposit was not the result of corrosion at this location. Rather, this deposit’s shape indicates that Magnetite was precipitated here due to decreased velocity (a by-product of PRV). Normally, this ultrafine particulate would be transported completely through the system, however here it has formed a “delta”.

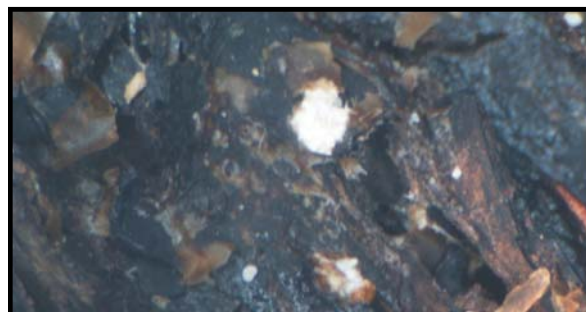
**Photomicrograph 1.** At 70X magnification, the deposit is revealed as an agglomeration of sand particulates, charred organics, hardness crystals, and other debris.

**COMMENTS:** The submitted pipe was segmented and one section’s deposit completely removed for analysis. Micro pitting was observed beneath the deposit, possibly the result of localized anion concentration (as a result of overheating due to fouling). Following ashing, acid digestion, and analysis via ICP instrumentation, the inorganic portion of the deposit was found to contain appreciable quantities of Phosphorous, Silicon, Sodium and Magnesium.

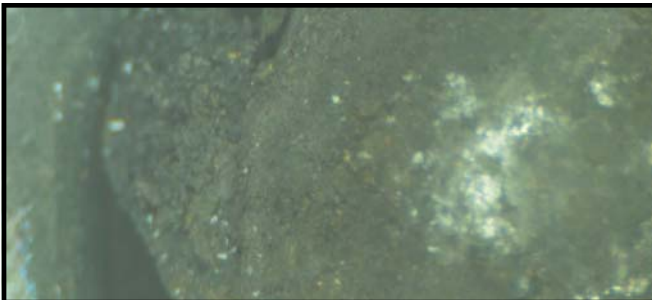
The submitted steam fitting has been examined as requested. Instrumental analysis of the deposit surrounding the ball revealed the material to be predominately Iron, with trace amounts of Copper, Lead and Chromium (from stainless steel).

The observed corrosion appears to be the result of under-deposit corrosion, abrasion and erosion corrosion. Ultrafine magnetite particulate, transported from well-passivated steam lines, has an electrostatic affinity for stainless steel. This affinity will allow small coatings of Magnetite to build on stainless steels and depending on physical and chemical conditions, lead to the failure observed in this sample.

**Photo 1.** Ball surface prior to cleaning.

Spirax/Sarco, the manufacturer of this steam trap, suggests maintenance 3-4 times a year on steam traps, with low-throughput traps requiring the most diligent inspection. It is not uncommon to replace all internal components when servicing a steam trap. Unfortunately, this particular trap's seat is not replaceable.

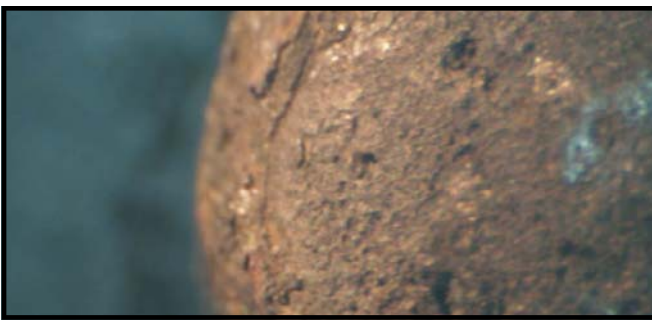
**Photo 2.** Ball surface after cleaning with corrosion byproducts/magnetite deposits removed.

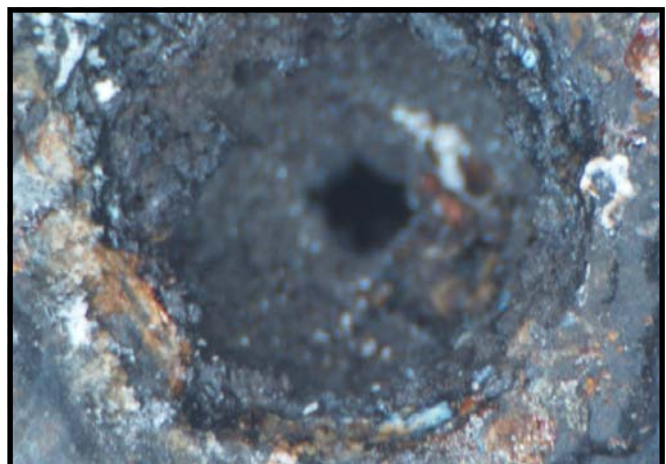
**Photo 3.** Ball "Seat" shows the evidence of general corrosion/abrasion prior to cleaning. The pinhole is centered (out of focus).
